Inventory Data:									
Structure Name	#8 Catons Bridge-N Structure, L10, C VII, Hungerford								
Main Hwy/Road#	Bethel Road	On <input checked="" type="checkbox"/>	Under	Crossing Type	Navig. Water Rail	Water Road	Non-Navig. Water Ped.	Water Other	
Hwy/Road Name	Carss Road								
Structure Location	1.30 Km S of Bethel Road								
Latitude	44.431189°N			Longitude	77.292011°W				
Owner(s)	Municipality of Tweed			Heritage Designation:	Not Cons. <input checked="" type="checkbox"/>	Cons./not App.	List/not Desig.		
MTO Region	Eastern			Road Class:	Freeway	Arterial	Collector	Local <input checked="" type="checkbox"/>	
MTO District	Kingston			Posted Speed	80km/h	No. of Lanes	1		
Old County				AADT		% Trucks			
Geographic Twp.				Inspection Route Sequence					
Structure Type	T-Beam			Interchange Number					
Total Deck Length	40.2 (m)			Interchange Structure Number					
Overall Str. Width	5.5 (m)			Min. Vertical Clearance

Field Inspection Information:	
Date of Inspection:	May 12, 2022
Inspector:	Abdul Rahman Stott
Others in Party:	Cody Chambers
Equipment Used:	Camera and hand tools
Weather:	Sunny
Temperature:	26°C

BRIDGE PHOTOGRAPHS

Structure Name: Catons Bridge North Structure
Locatio

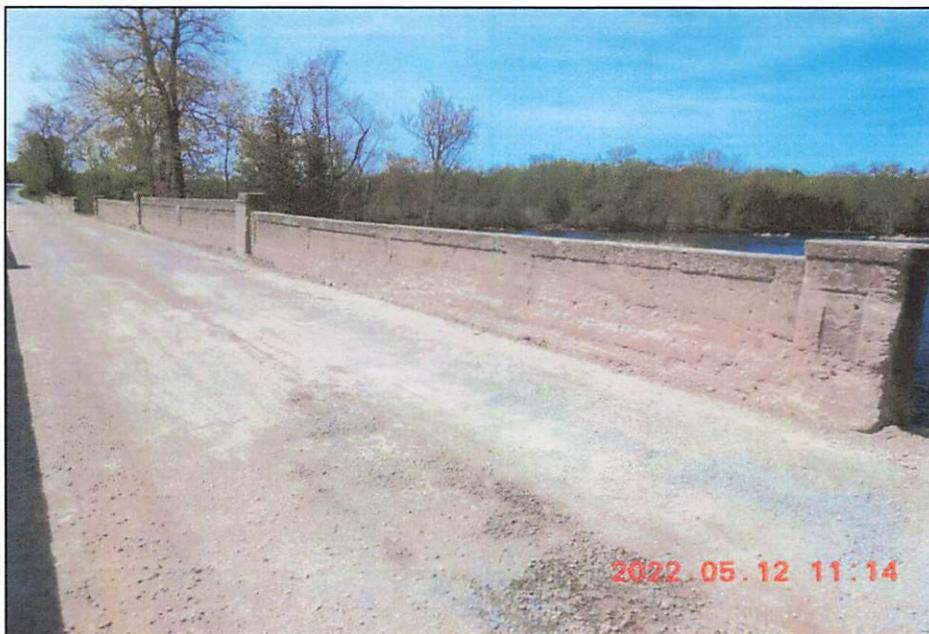
Photo 2: Scaling on West Interior Barrier Wall

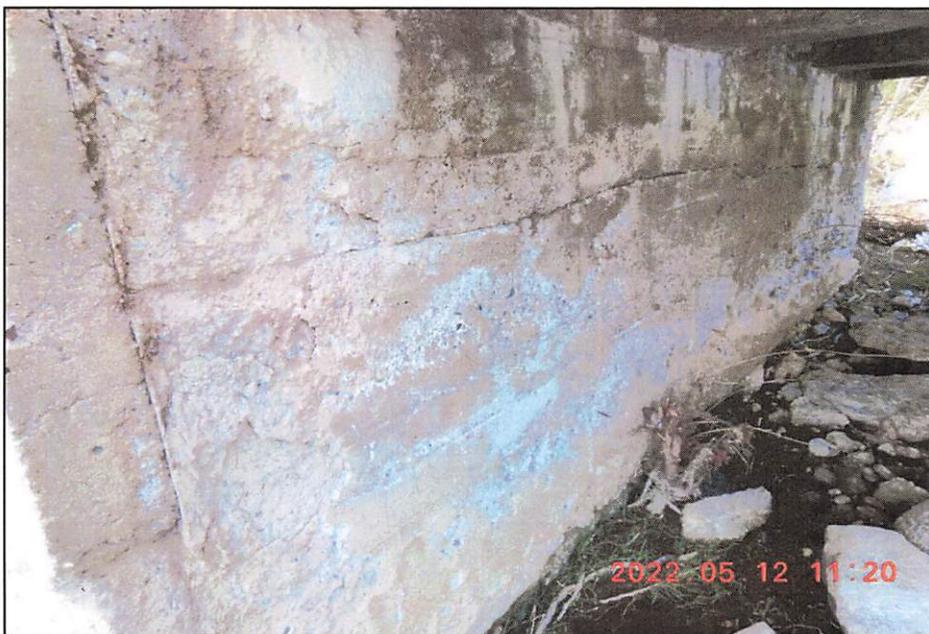
Photo 4: Scaling, Cracking, and Efflorescence on South Abutment Wall

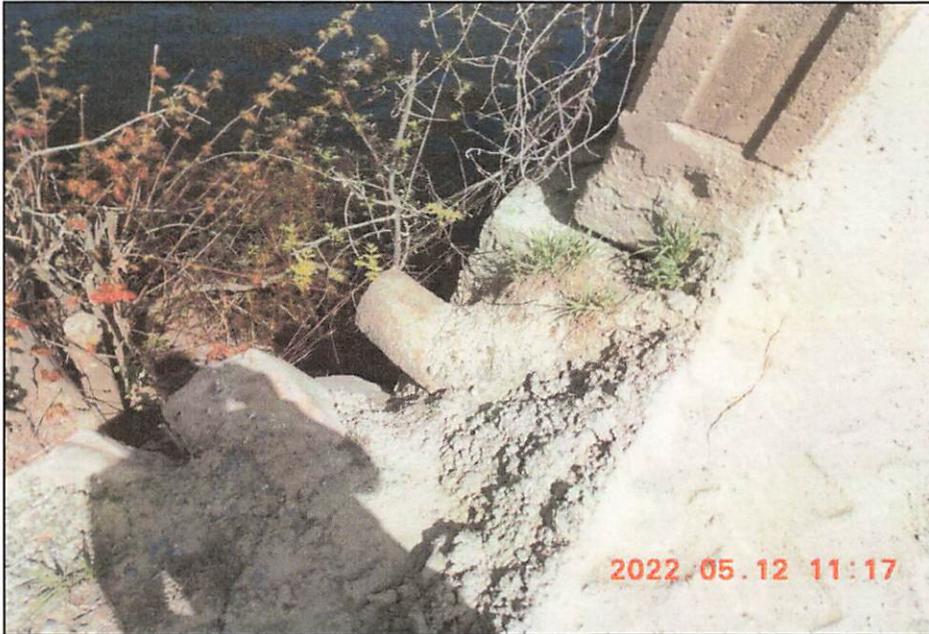
Photo 7: Erosion of Approach over Southwest Retaining Wall

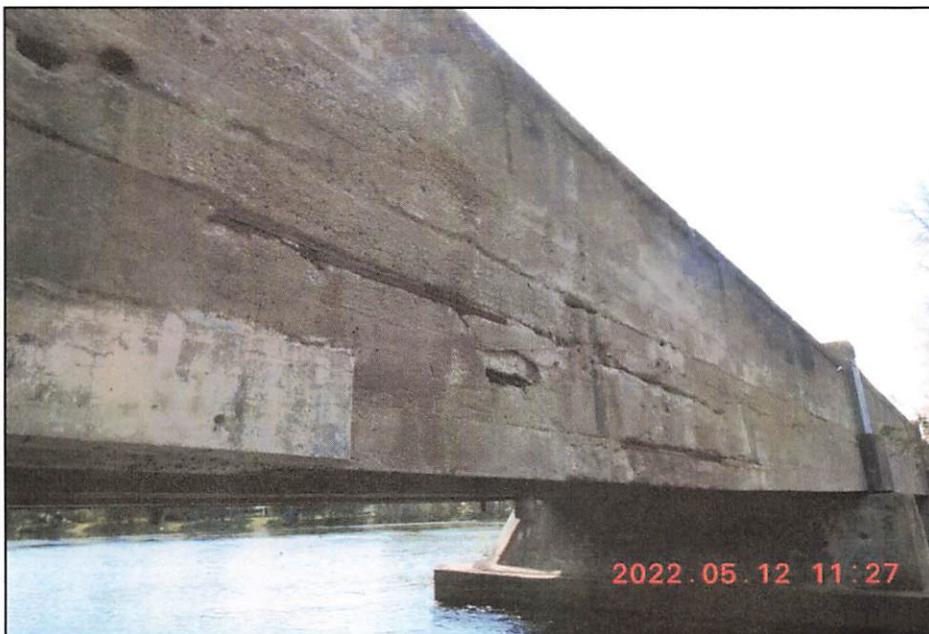
Photo 8: Scaling, Patching, and Spalling with Exposed Rebar on West Exterior T-Beam

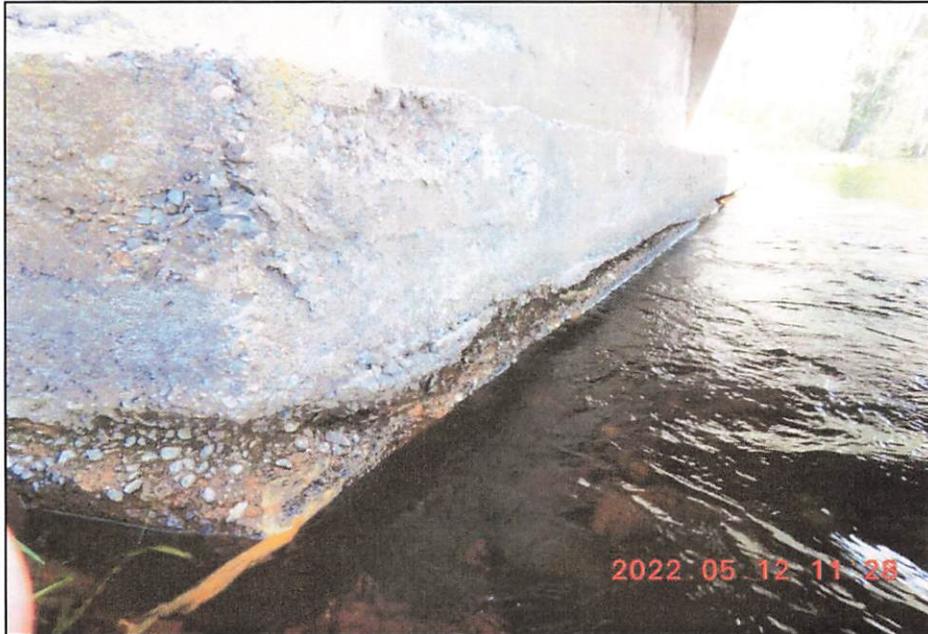
Photo 9: Erosion on North Abutment Footing

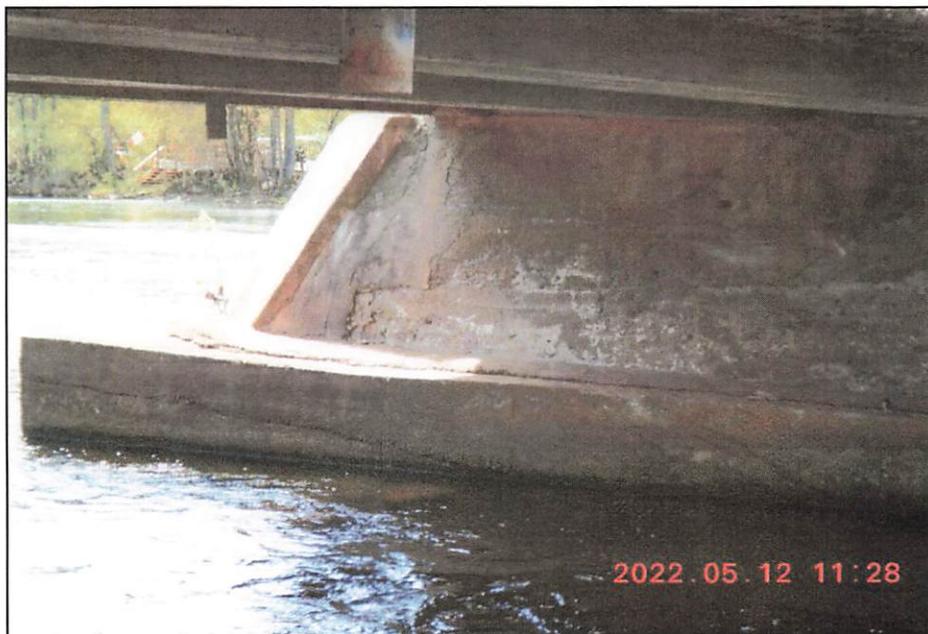
Photo 10: Scaling, Erosion, and Cracking on North Pier North Face

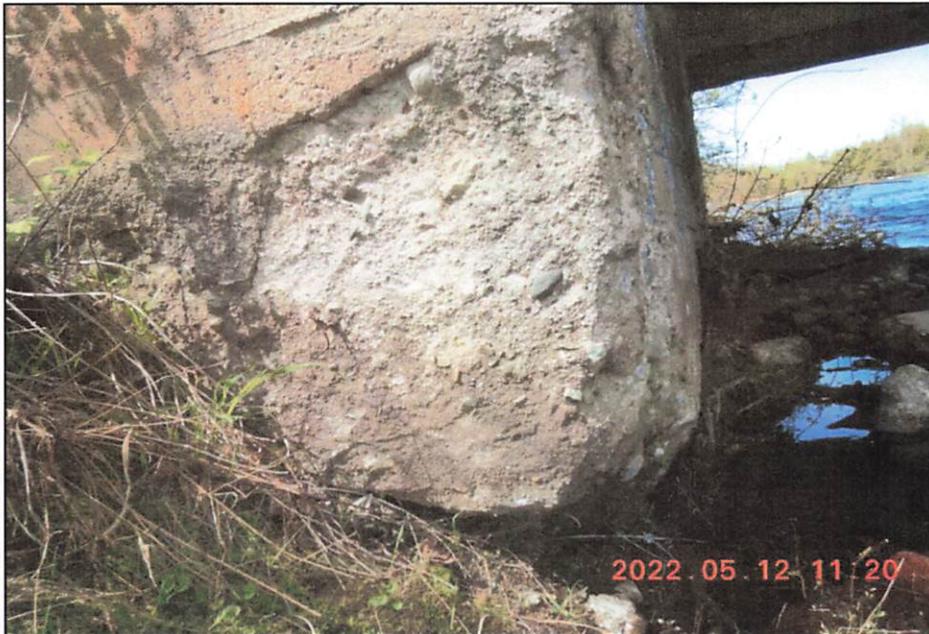
Photo 11: Erosion and Undermining on Southeast Abutment Wall

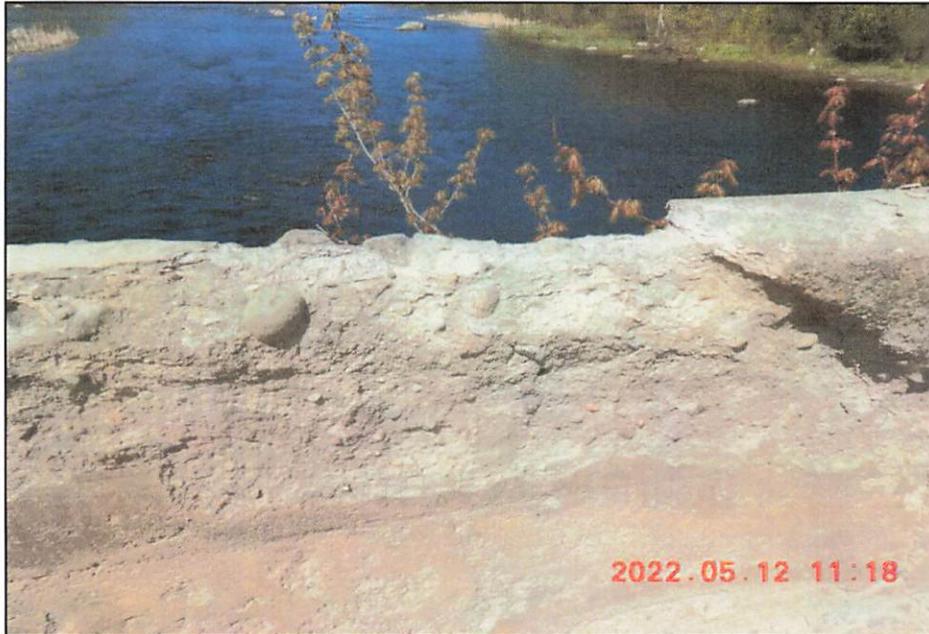
Photo 13: Scaling on Interior Barrier Wall

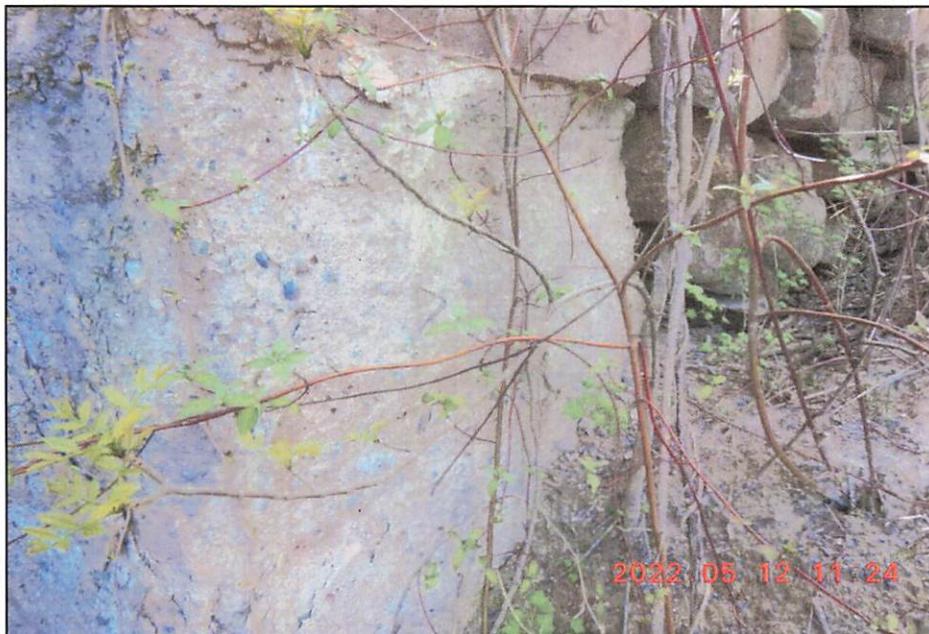
Photo 14: Scaling on Southwest Wingwall

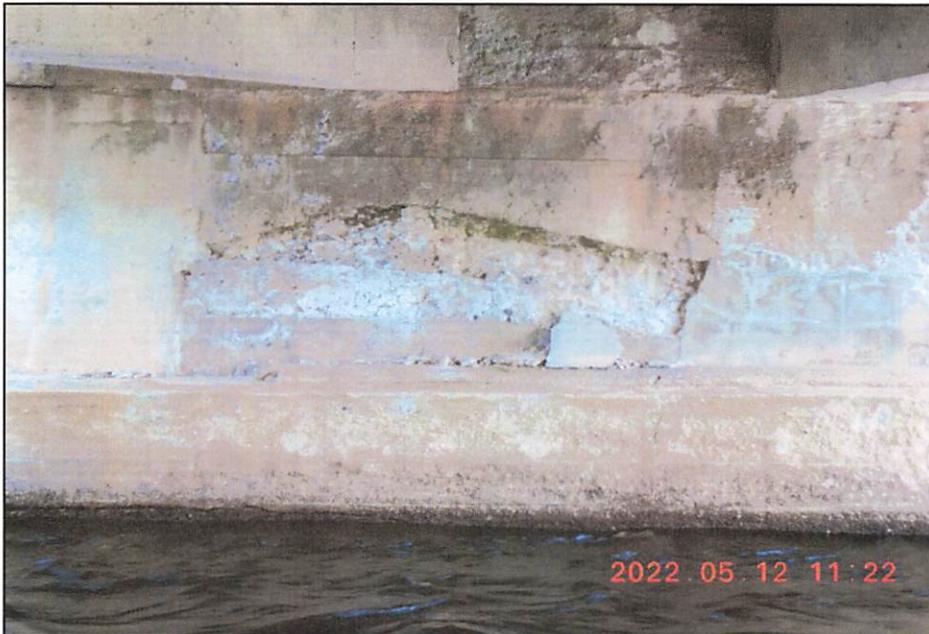
Photo 15: Spalling, Cracking with Efflorescence, and Erosion on South Pier, South Face

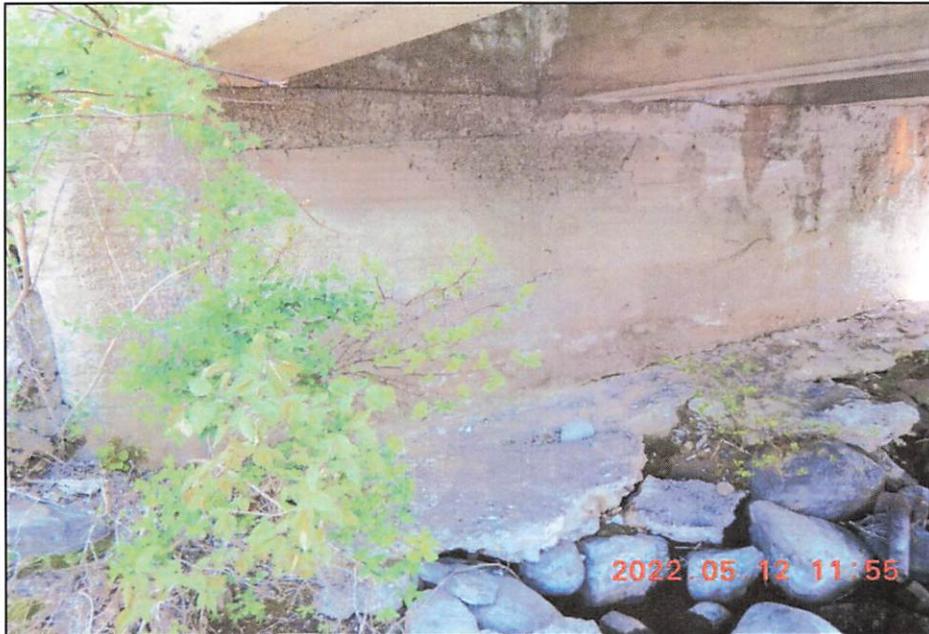
Photo 3: Scaling and Cracking with Efflorescence on North Abutment Wall

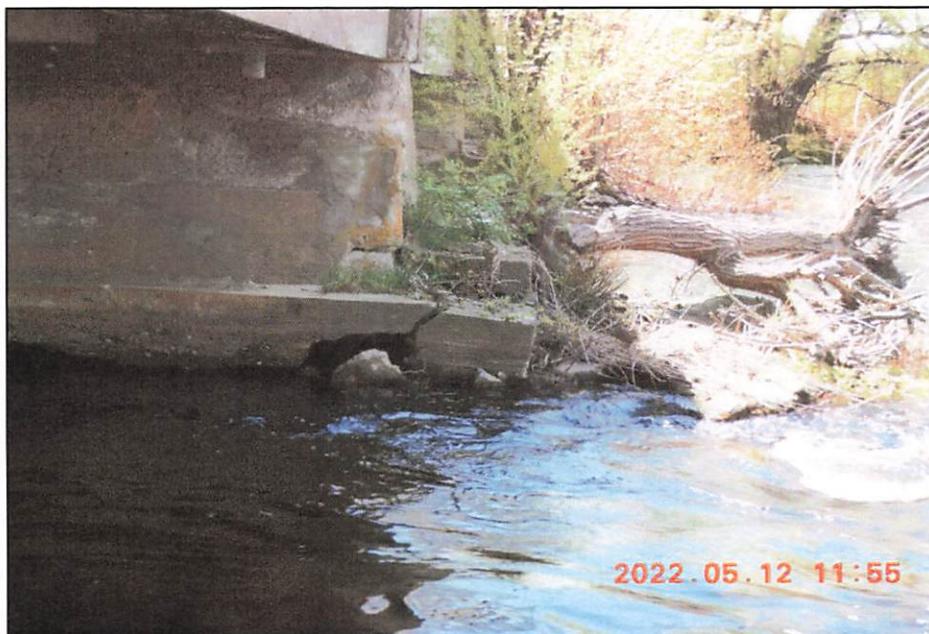
Photo 4: Scaling, Erosion, and Spalling on North Pier North Face

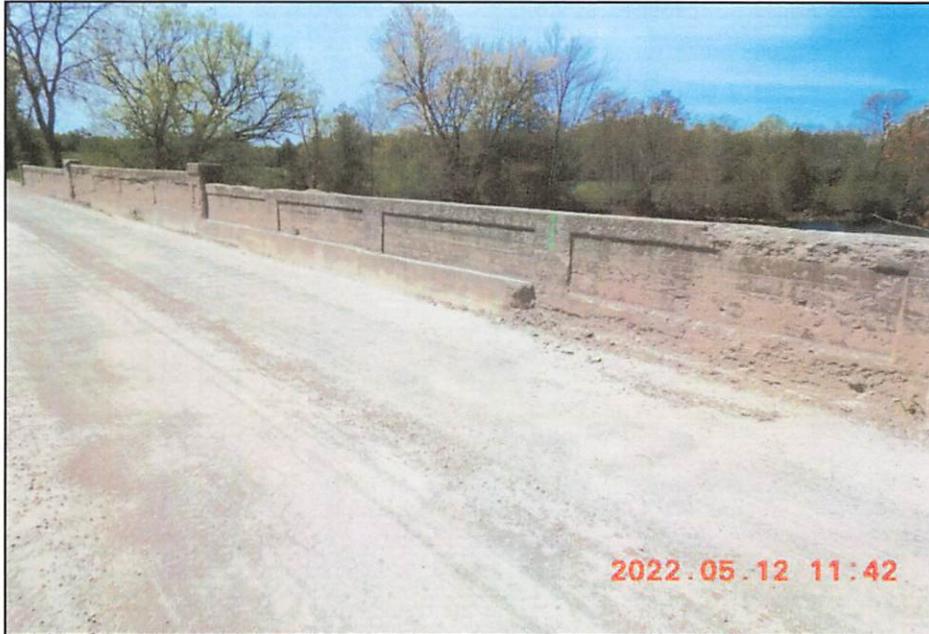
Photo 5: Scaling on West Interior Barrier Wall

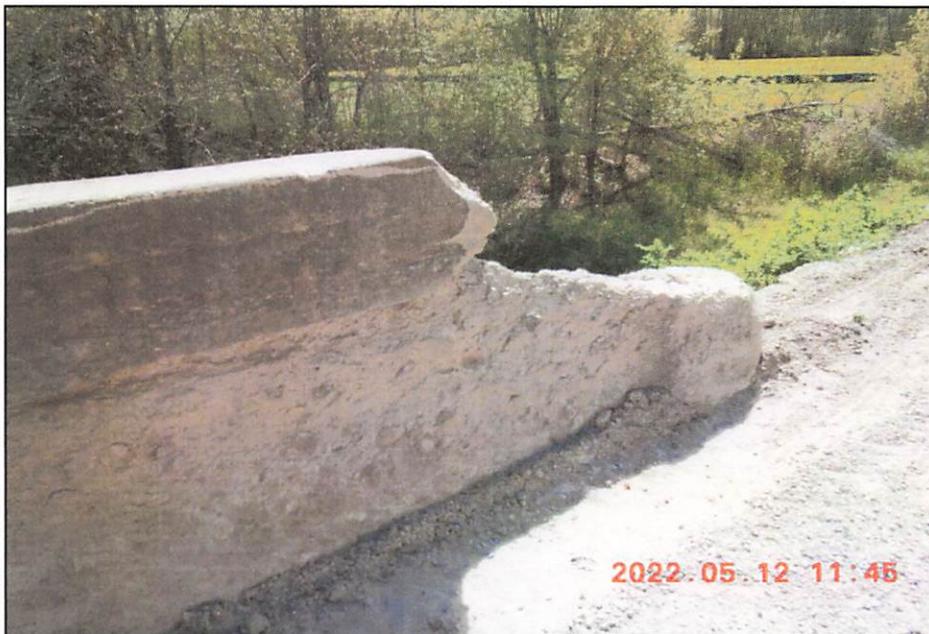
Photo 6: Disintegration and Spalling on West Interior Barrier Wall End

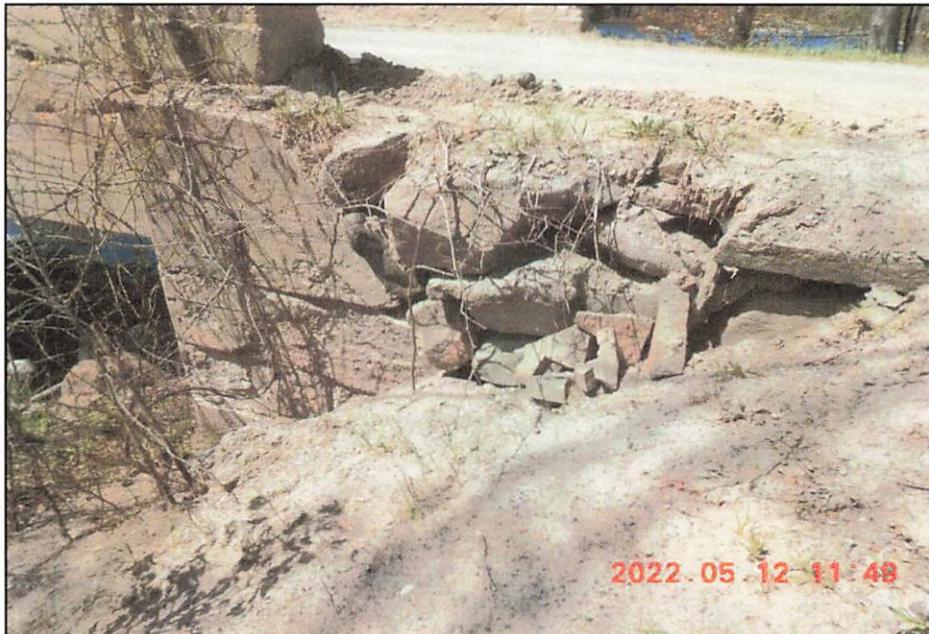
Photo 7: Seperatory Cracking, Scaling, and Tilting on Northeast Wingwall and Failed Retaining Wall

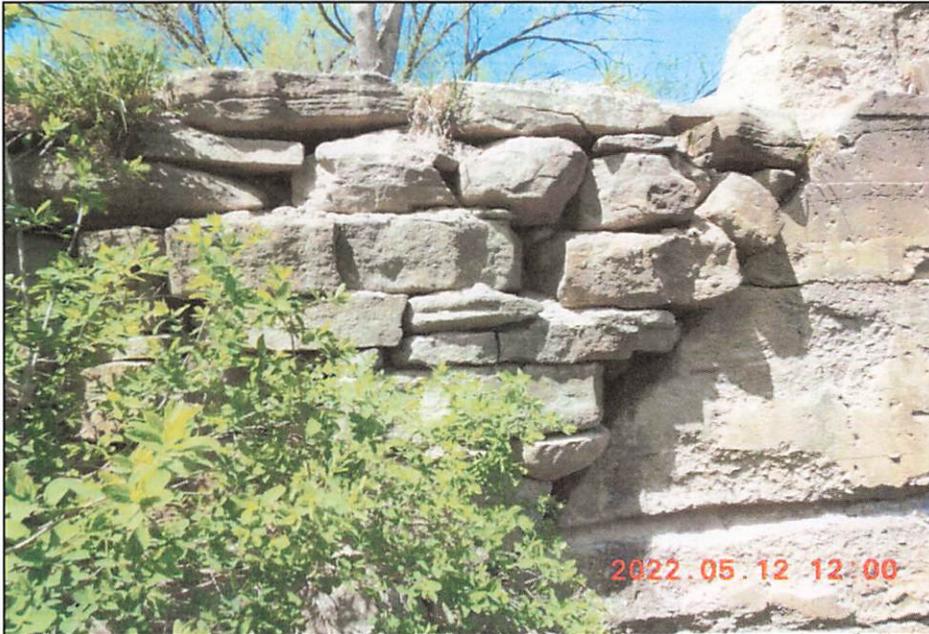
Photo 9: Scaling and Cracking on Northeast Wingwall and Bulging on Retaining Wall

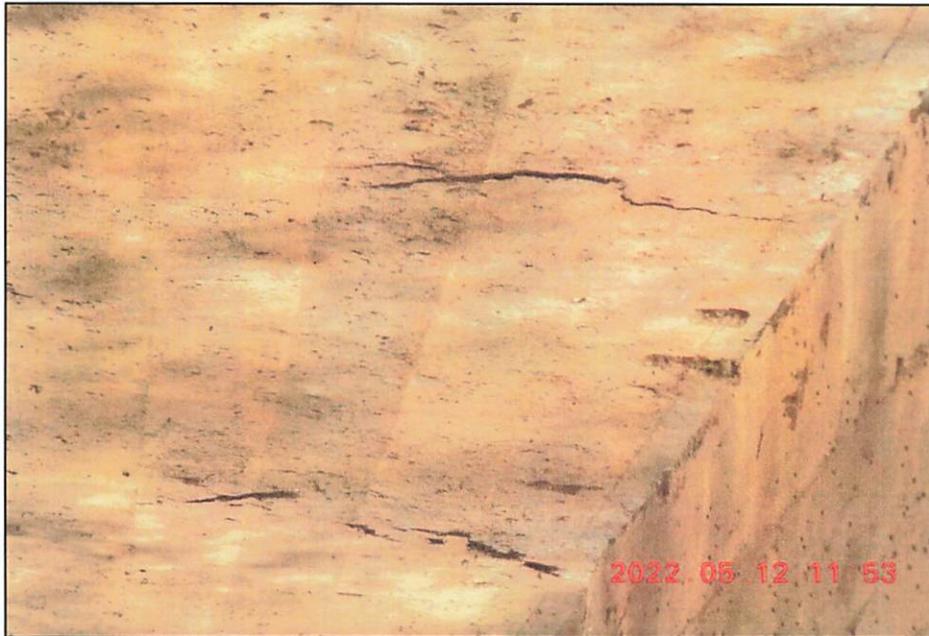
Photo 11: Delamination on North Span Soffit

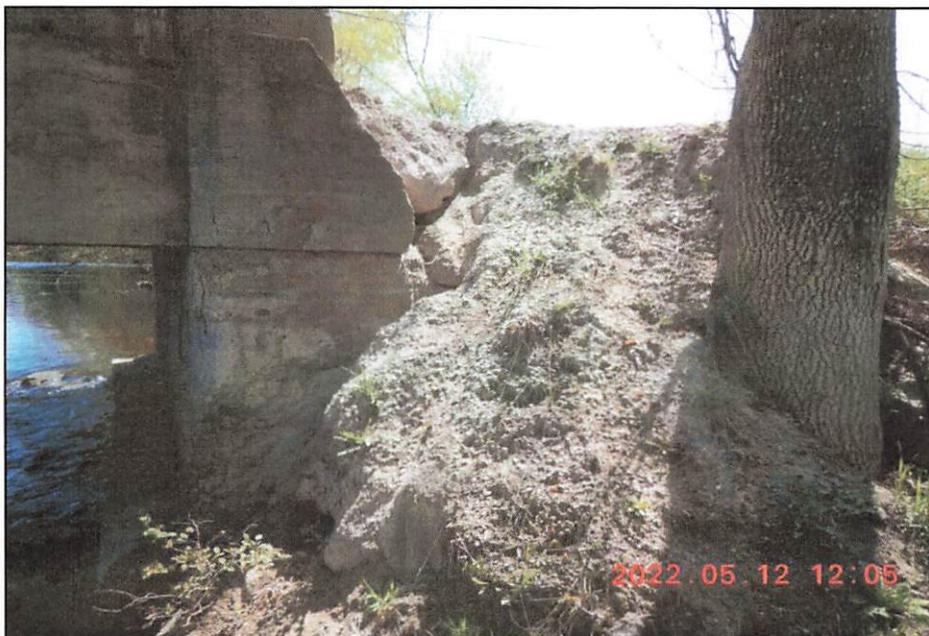
Photo 12: Failed Southwest Retaining Wall

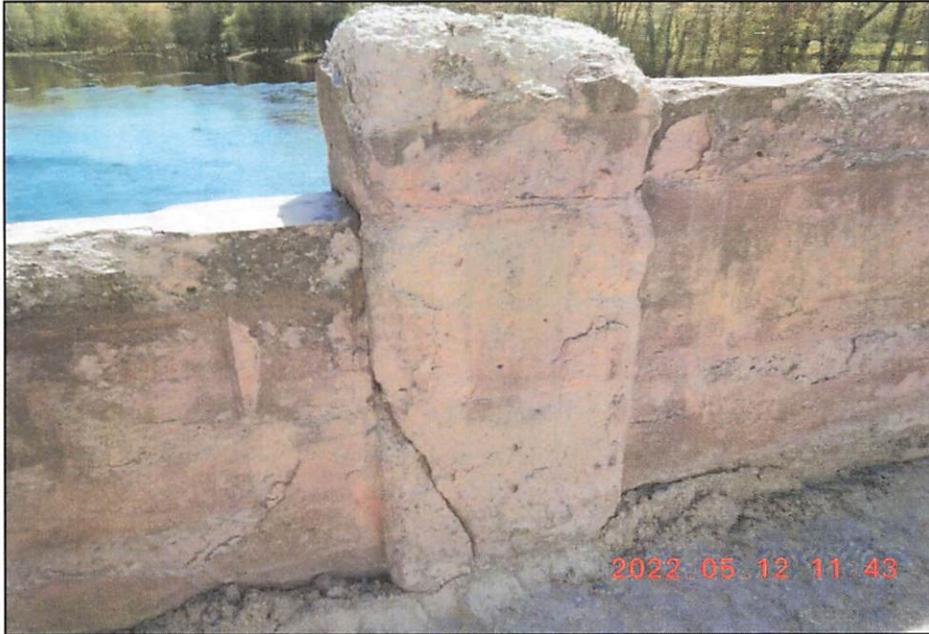
Photo 13: Scaling and Scaling on East Interior Barrier Wall

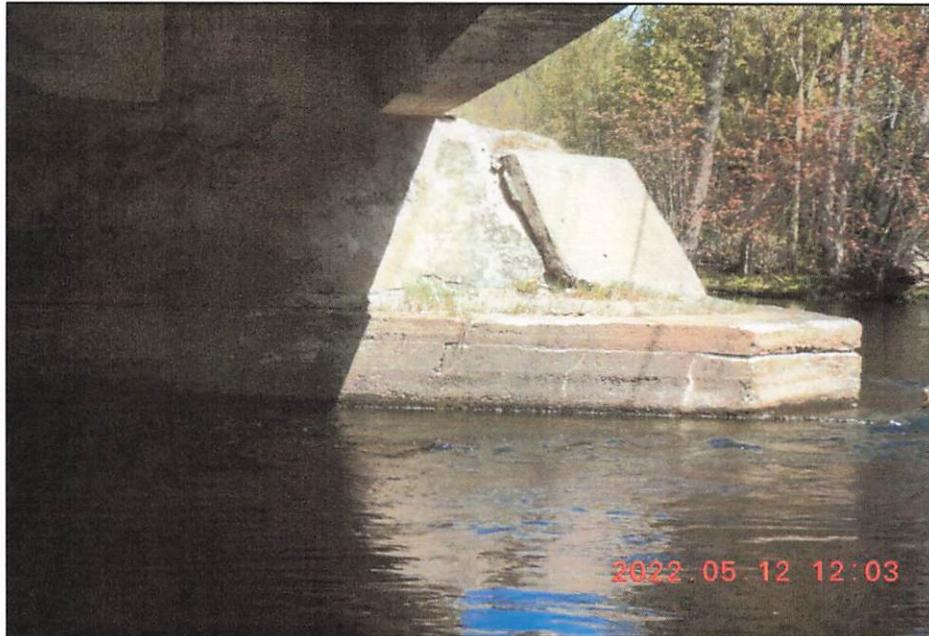
Photo 15: Spall on South Pier South Face
