| Inventory Data: | |
|---|--|
| Structure Name | #30 East Red Bridge, Elzevir |
| Hwy/Road Name | Black River Road |

**BRIDGE PHOTOGRAPHS**

Structure Name: East Red Bridge

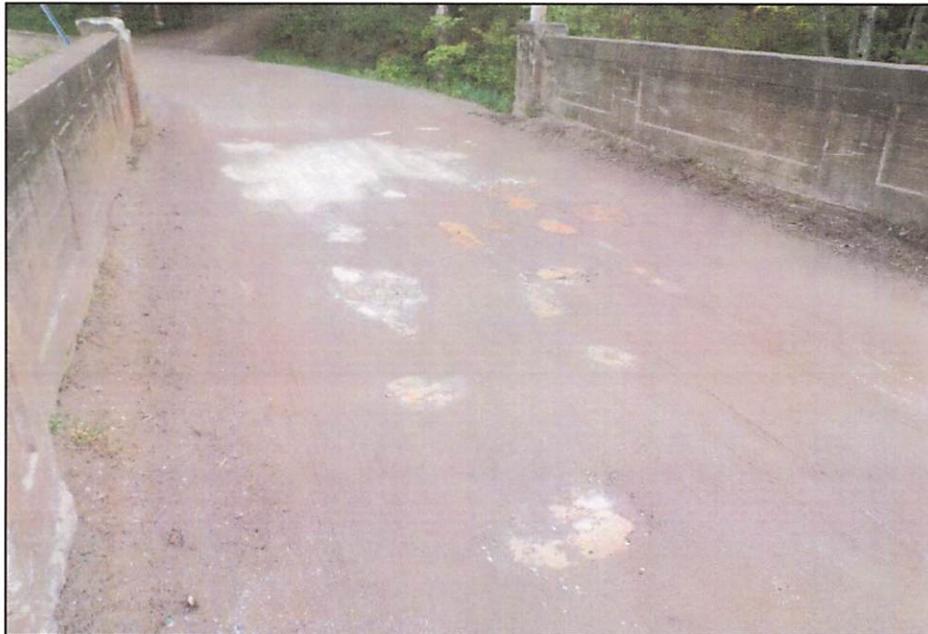
| Comments: Deck is mostly covered with debris. Pothole formation with ponding, localized severe scaling. | | | | | | | |

*Photo 1: Pothole Formation on Deck Top Looking East*

| Recommended Work: Resurface deck as part of major rehabilitation      None <input type="checkbox"/> 6-10 years <input type="checkbox"/> 1-5 years <input checked="" type="checkbox"/> <1 year <input type="checkbox"/> Urgent <input type="checkbox"/> | | | | | | | |

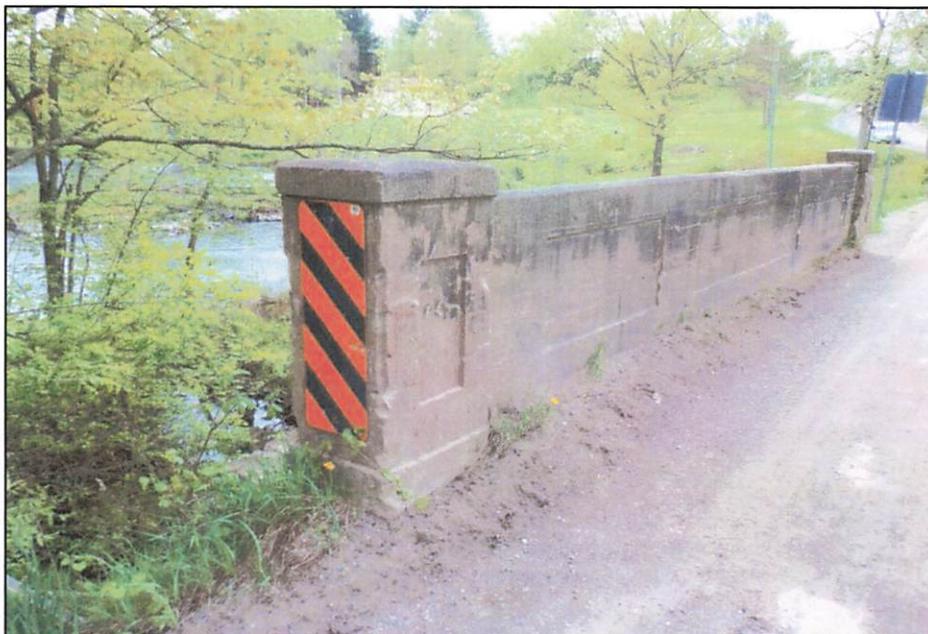
| Comments: Wide cracks and spalling on posts. Southwest post is spalled. Severe scaling on north wall and along base of walls. Localized spalling. Severe erosion at base of north wall. Moderate to severe AAR. Northeast post is partially scaled. | | | | | | | |

*Photo 2: South Interior Barrier Wall*

| Recommended Work: Remove and replace barrier walls with code-compliant rail system. None <input type="checkbox"/> 6-10 years <input type="checkbox"/> 1-5 years <input checked="" type="checkbox"/> <1 year <input type="checkbox"/> Urgent <input type="checkbox"/> | | | | | | | |

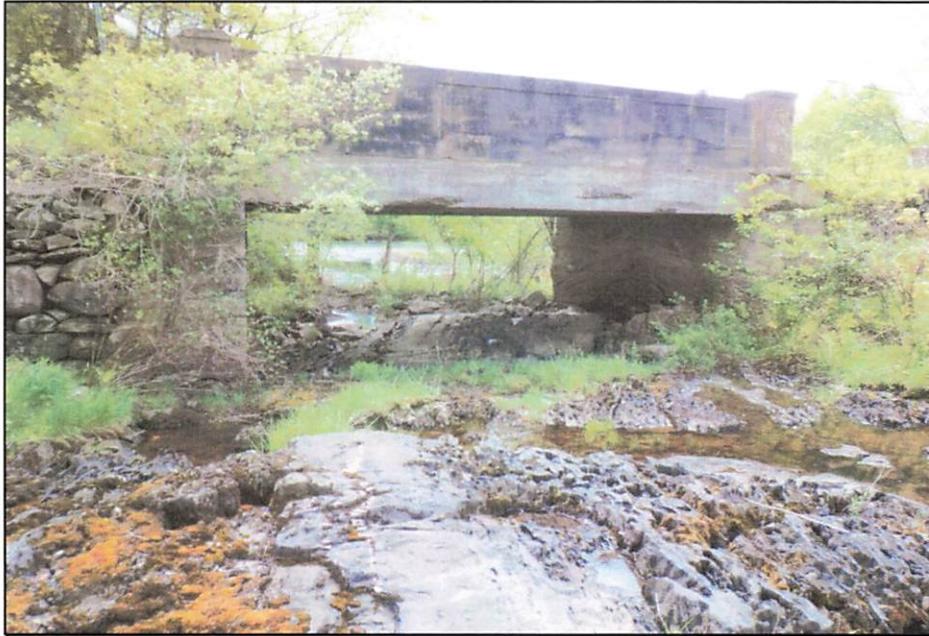
*Photo 3: North Elevation*

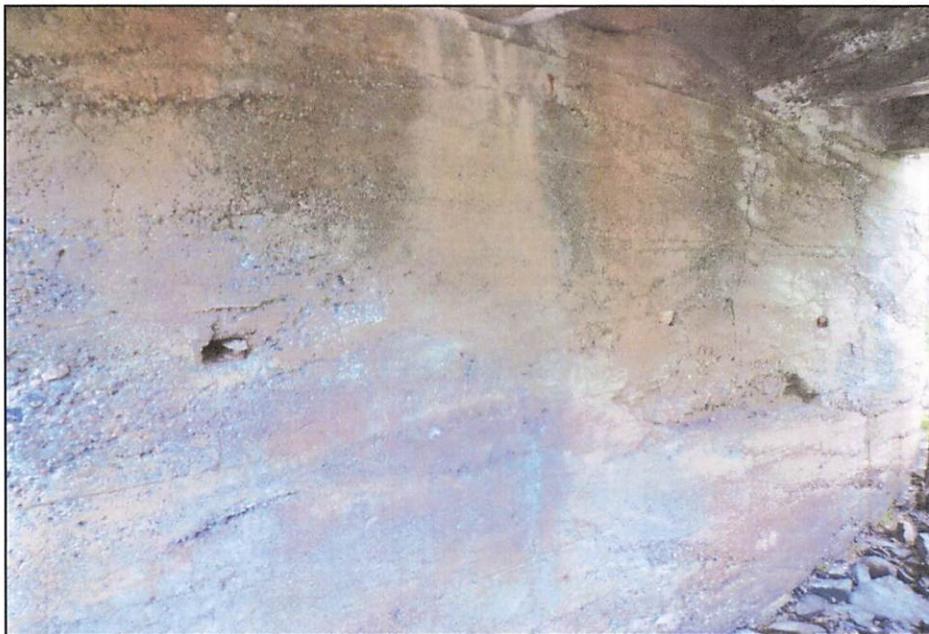
| Comments: Light to severe scaling and honeycombing. Severe undermining of both abutments. Wide horizontal cracks. Wide full-height crack in east abutment. | | | | | | | | | | | |

*Photo 4: East Abutment Wall*

| Recommended Work: Complete abutment refacing as part of major rehabilitation | | | | | | | | | | | |

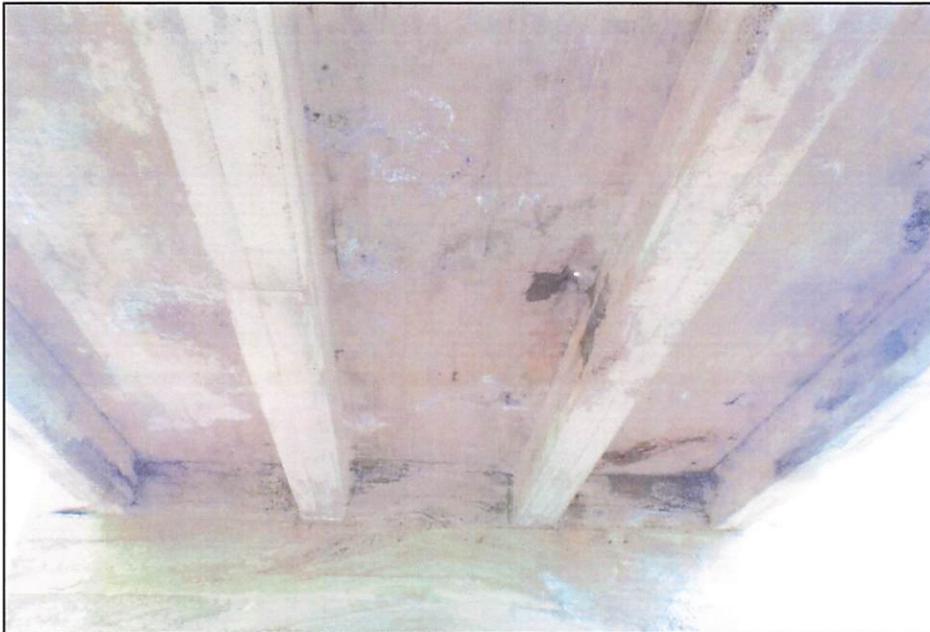
| Comments: Medium to severe scaling on exterior beams. Typical scaling and disintegration. Localized delamination, spalling, and wide horizontal cracks. | | | | | | | |

*Photo 5: Interior Girders and Soffit Looking West*

| Recommended Work: Complete patch repair of t-beams as part of major rehabilitation. None <input type="checkbox"/> 6-10 years <input type="checkbox"/> 1-5 years <input checked="" type="checkbox"/> <1 year <input type="checkbox"/> Urgent <input type="checkbox"/> | | | | | | | |

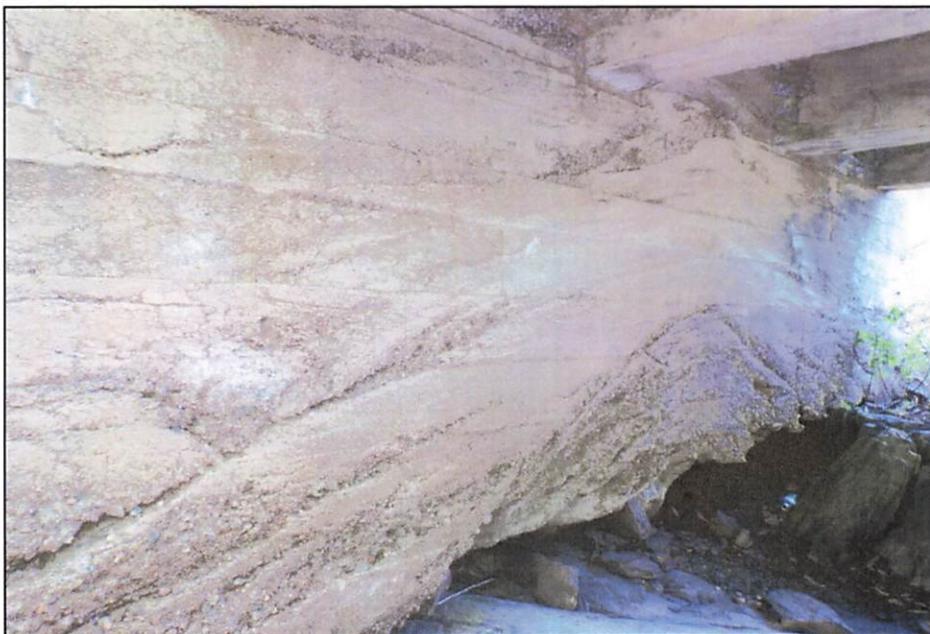
*Photo 6: Erosion on West Abutment Wall*

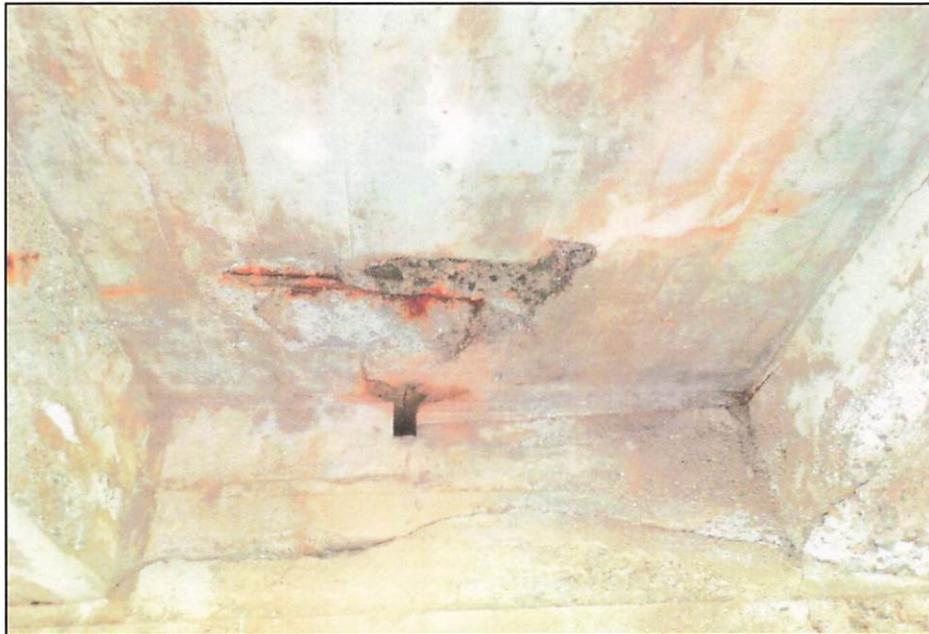
| Comments: Transverse cracking with corrosion staining. Efflorescence deposits at abutments. Localized spalls and severe scaling with exposed and corroded rebar near bored areas | | | | | | | |

*Photo 7: Spalling with Corrosion Staining in Soffit*

| Recommended Work: Complete patch repairs as part of major rehabilitation      None <input type="checkbox"/> 6-10 years <input type="checkbox"/> 1-5 years <input checked="" type="checkbox"/> <1 year <input type="checkbox"/> Urgent <input type="checkbox"/> | | | | | | | |

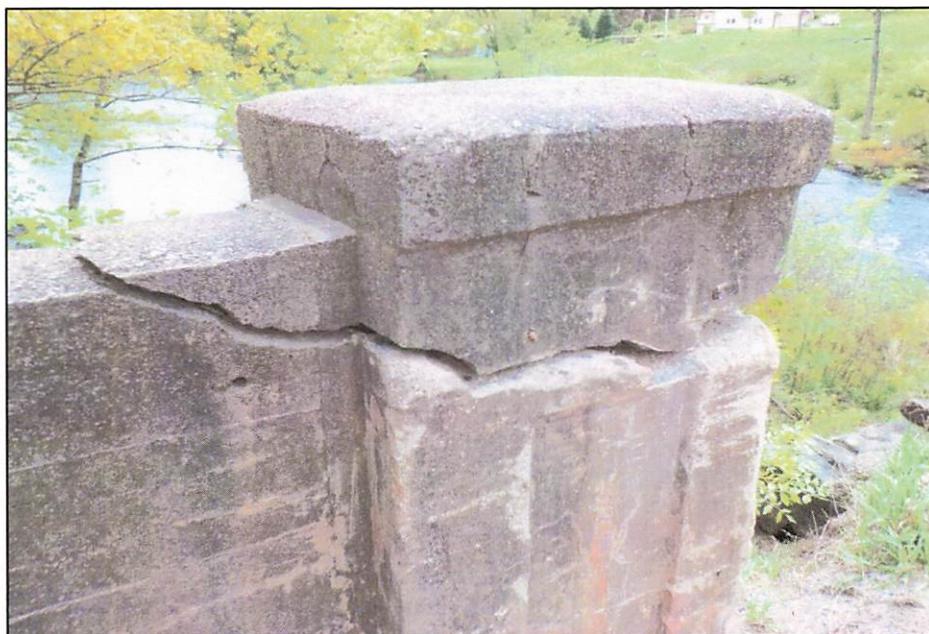
*Photo 8: Spalled Southwest Barrier Post*

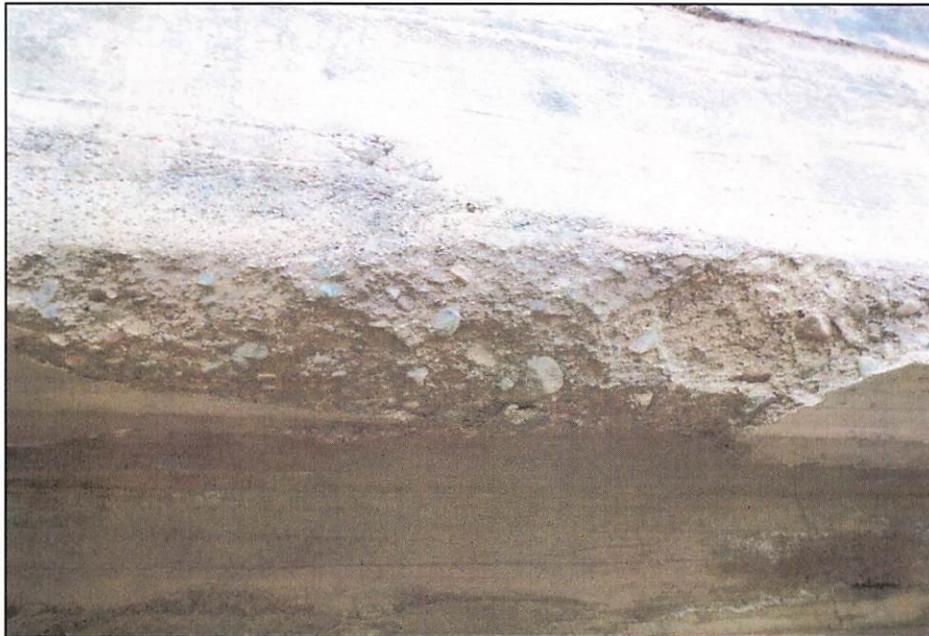
*Photo 9: Scaling on North Exterior T-Beam*

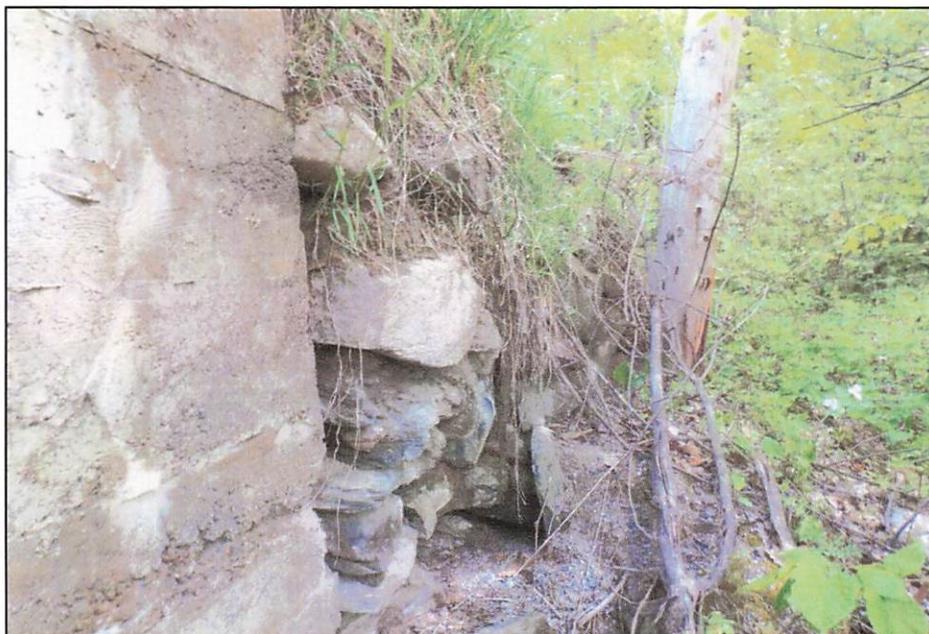
| Comments: Outward shifting of stones. Soil/engineered fill washout above retaining walls. Southeast wall exhibits loss of backfill. Southwest wall is failing and exhibits loss of backfill. | | | | | | | | | | | |

*Photo 11: Outward Rotation of Northwest Retaining Wall*

| Recommended Work: Reinstate retaining walls as part of major rehabilitation | | | | | | | | | | | |

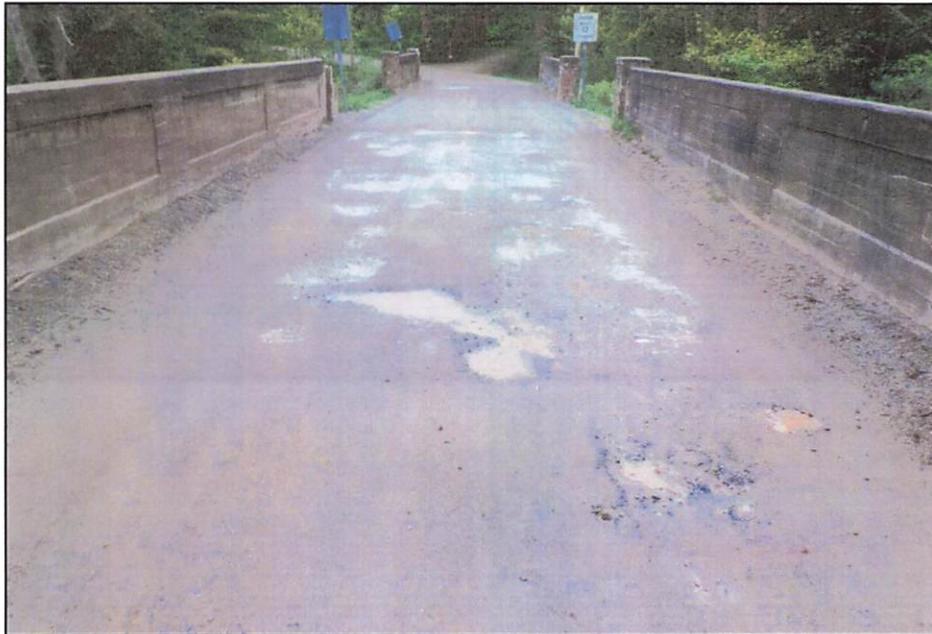
| Comments: Medium to severe scaling and spalling. Significant accumulation of debris | | | | | | | |

*Photo 1: Pothole Formation on Deck Top Looking East*

| Recommended Work: Clean bridge deck as part of regular maintenance. Complete patch repairs as part of major rehabilitation | | | | | | | |

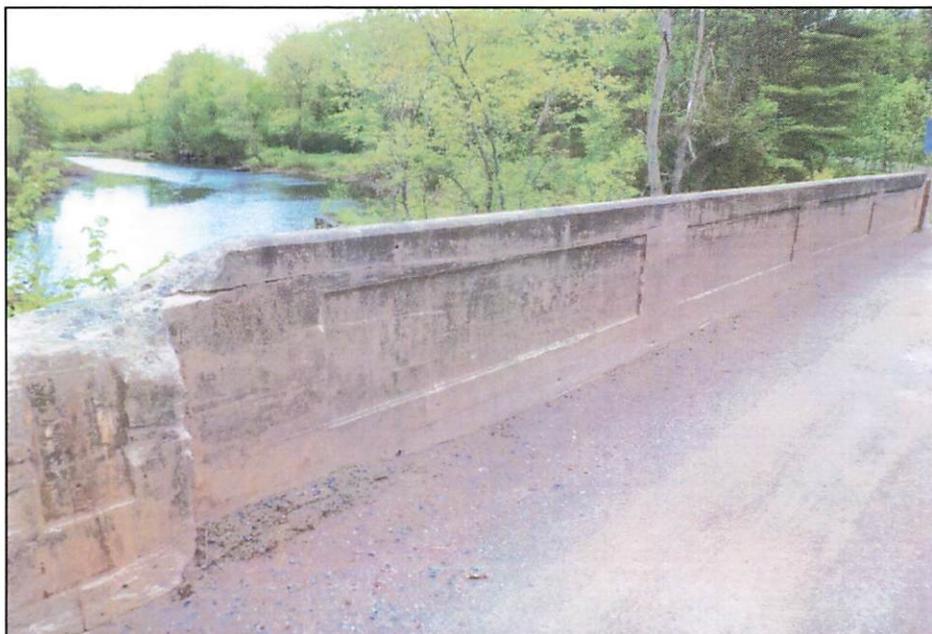
*Photo 2: North Interior Barrier Wall*

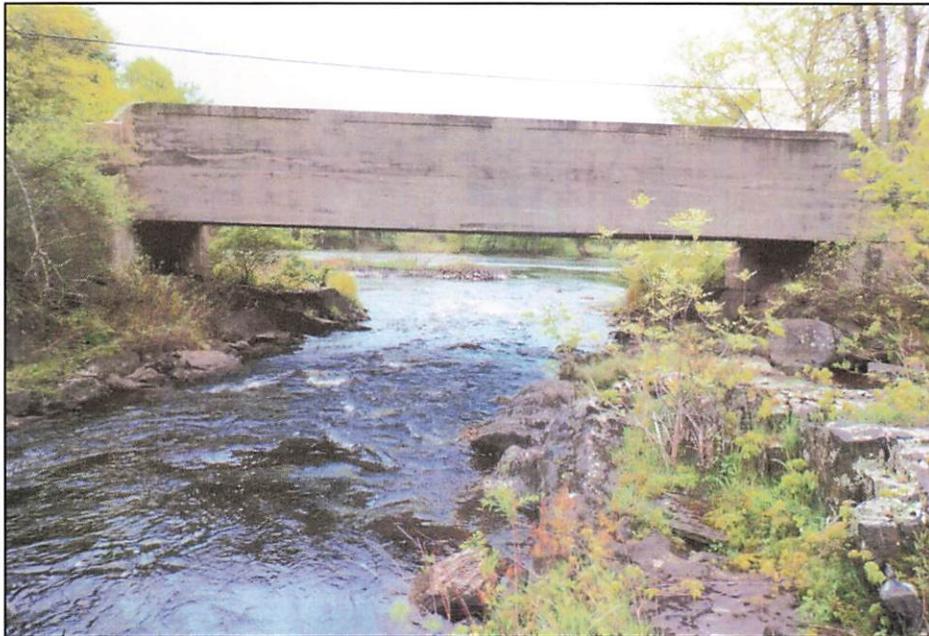
*Photo 3: North Elevation*

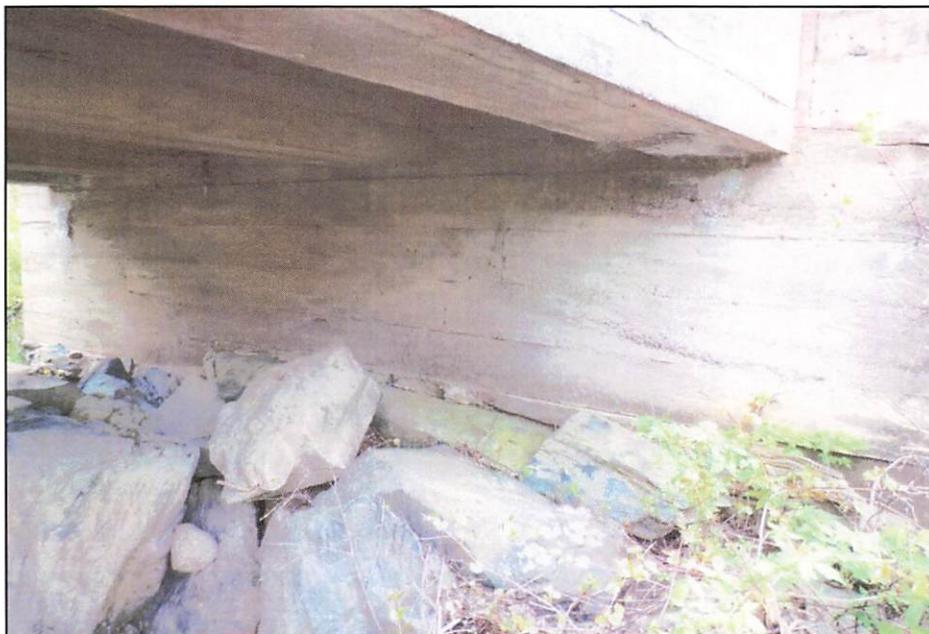
| Comments: Vertical full height crack in west abutment. Localized delamination. Separation at construction joints at the edges of the walls. Medium to severe erosion and light to medium scaling. | | | | | | | | |

*Photo 4: West Abutment Wall*

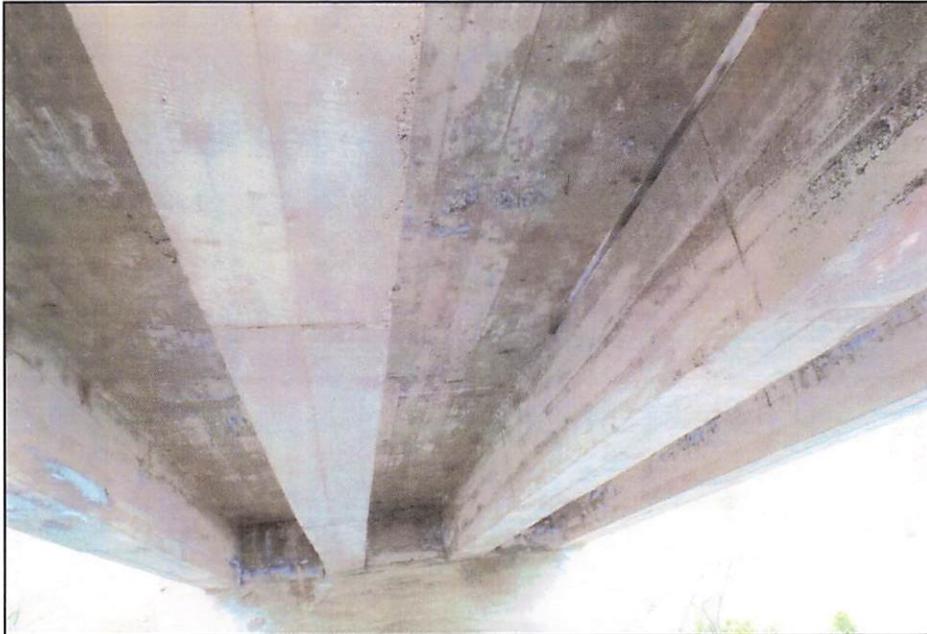
*Photo 5: Interior T-Beams and Soffit Looking East*

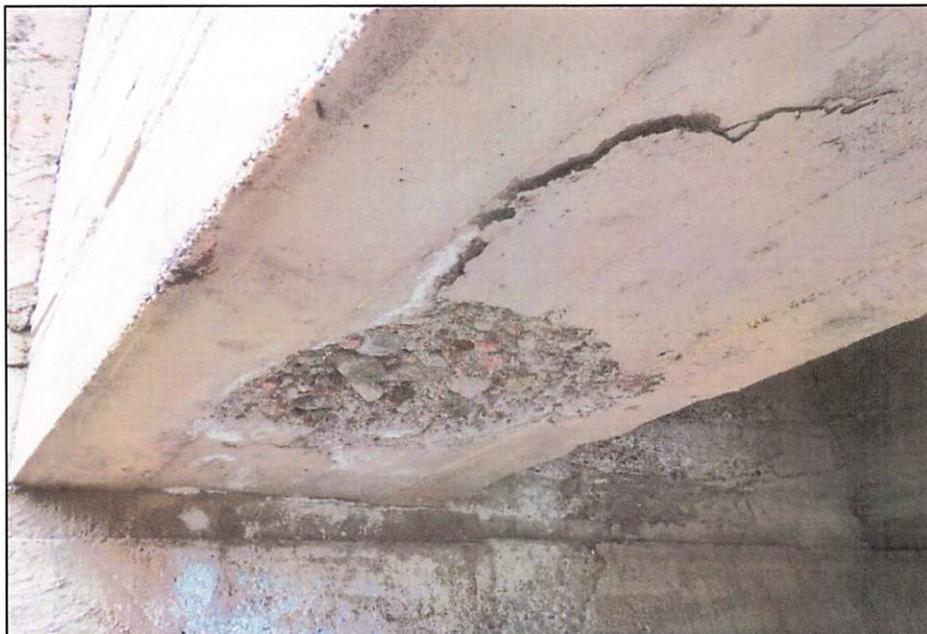
*Photo 6: Spalling and Delamination on Exterior T-Beam*

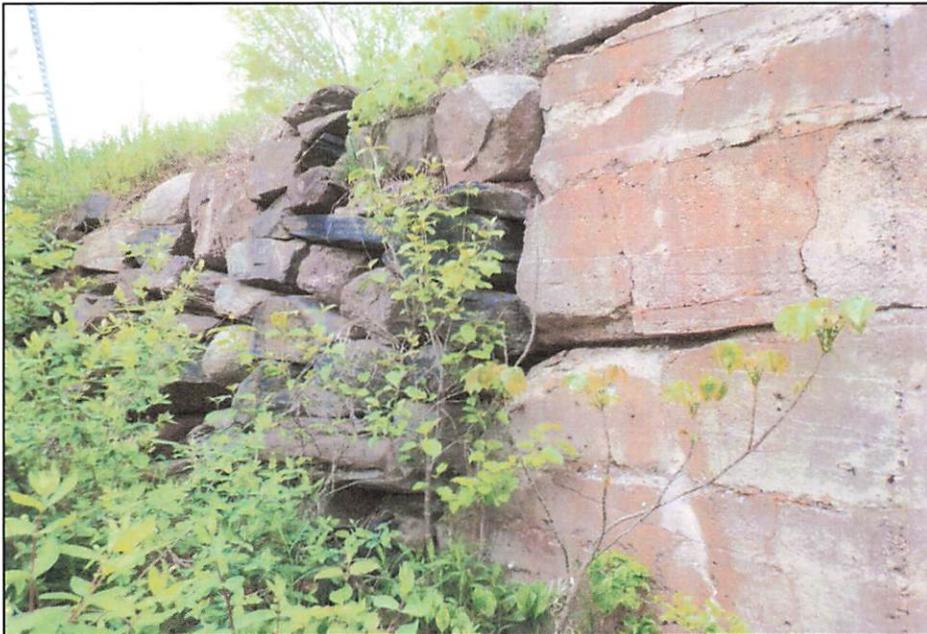
| Comments: Wide cracks and disintegration at construction joints. Full-width separatory cracking at southwest abutment due to retaining wall bearing. | | | | | | | | |

| Comments: Northeast, northwest, and southeast walls is failing with washouts on shoulders above and loss of backfill material. All walls are rotating outwards | | | | | | | | |

*Photo 7: Bulging of Retaining Wall and Seperatory Cracking on Wingwall at Southwest Quadrant*

| Recommended Work: Complete patch repairs and reinstatement of wingwalls None <input type="checkbox"/> 6-10 years <input type="checkbox"/> 1-5 years <input checked="" type="checkbox"/> <1 year <input type="checkbox"/> Urgent <input type="checkbox"/> | | | | | | | | |

| Recommended Work: Reinstatate retaining walls as part of major rehabilitation None <input type="checkbox"/> 6-10 years <input type="checkbox"/> 1-5 years <input checked="" type="checkbox"/> <1 year <input type="checkbox"/> Urgent <input type="checkbox"/> | | | | | | | | |

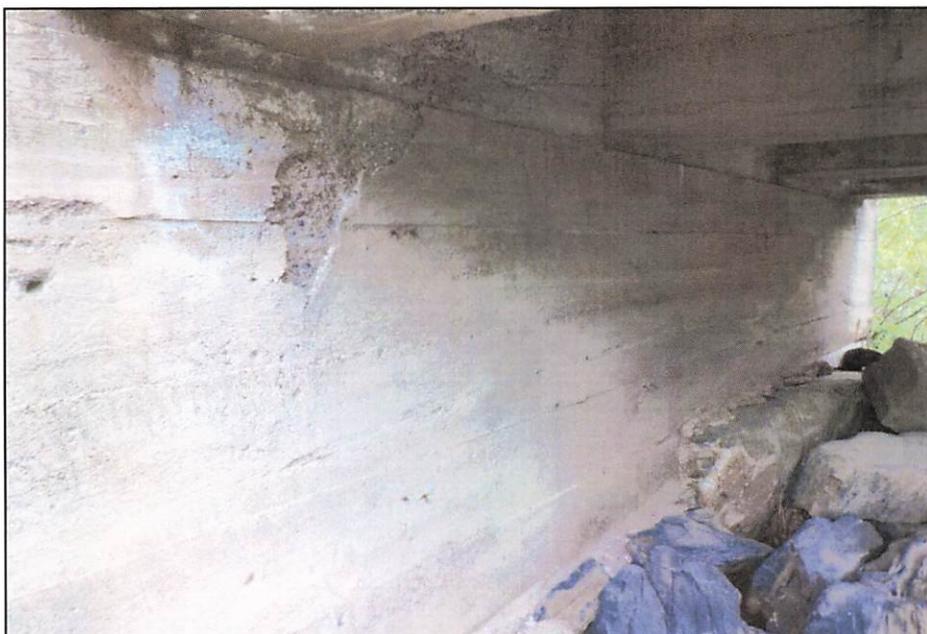
*Photo 8: West Abutment Wall*

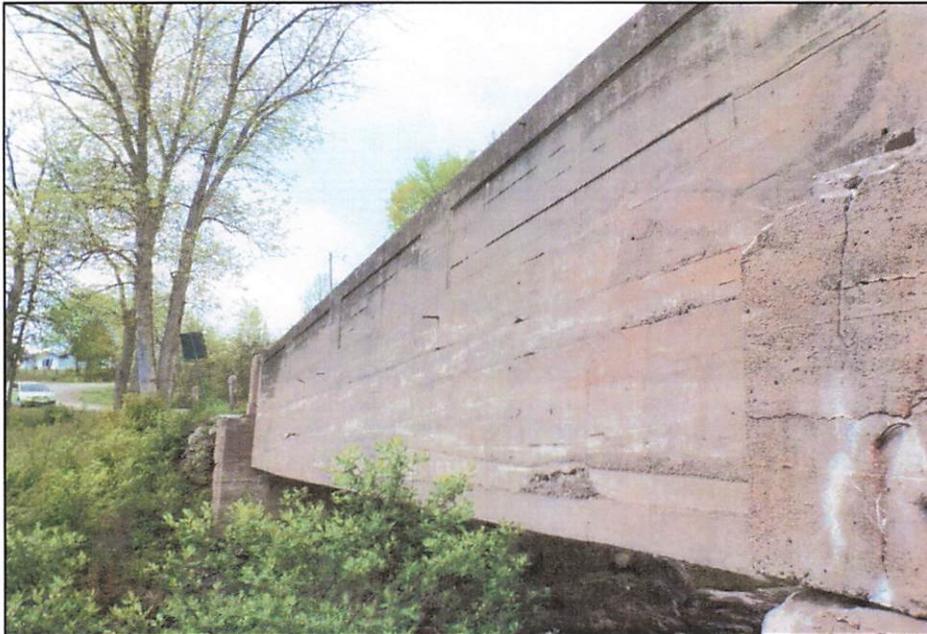
*Photo 9: South Exterior Fascia and Barrier Wall Looking West*

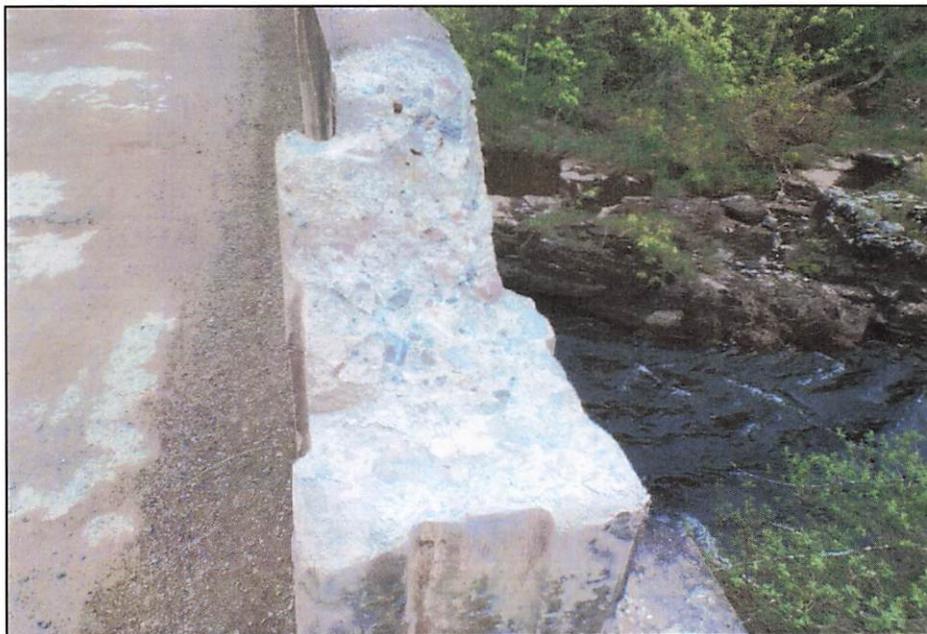
*Photo 10: Spall on Northeast Barrier Wall*
